KEPAIRING AND CHECKING METHODS OF CAL. 6138A AND 6139A

In spite of being a multi-functional watch classified as an "automatic winding chronograph," 6138A and 6139A are designed to facilitate repairs through SEIKO's extremely simplified and unique construction. However, compared with ordinary watches, since inspection and adjustment of the chronograph mechanism are added, increased difficulties arise in making repairs to these watches.

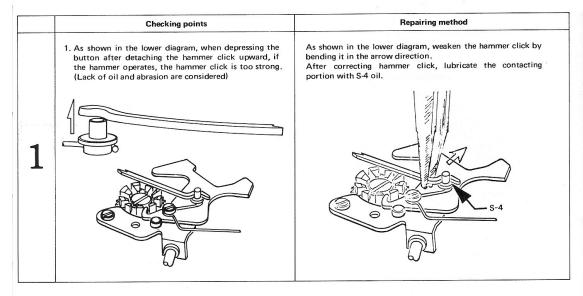
1) When the button cannot be depressed Is the hammer click too strong or is it worn?

2) When the button can be depressed Has the fly-back lever pin slipped completely in or is it detached? Does the hammer return?

Checking points	Repairing method
2	2. Checking of sunken or detached fly-back lever pin. The pin is sank Pin is detached	Pull out sunken pin. When the hammer is bent, flatten it correctly. Replace the fly-back lever Caulk it correctly
3	3: Check whether or not the hammer spring is on the bridge. As the spring is obstructed by the bridge it does not work.	Correct the spring tip as shown in the lower diagram.

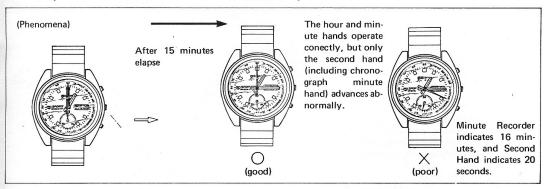
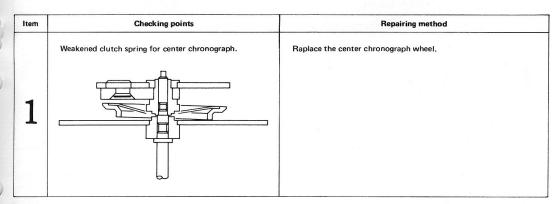
Mark the Center Chronograph wheel and the tip of the chronograph finger as shown in the diagram.

(Do not slide the center chronograph wheel or clutch spring in a condition that the clutch spring the center chronograph wheel contact each other)

Operate with the starting button, and check whether or not the mark slips.

If the mark gradually slips, the center chronograph wheel is defective.
